Noise and Vibration Control for a Decanting Centrifuge

A thesis submitted in partial fulfilment of the requirements

for the Degree of Master of Engineering

at the University of Canterbury

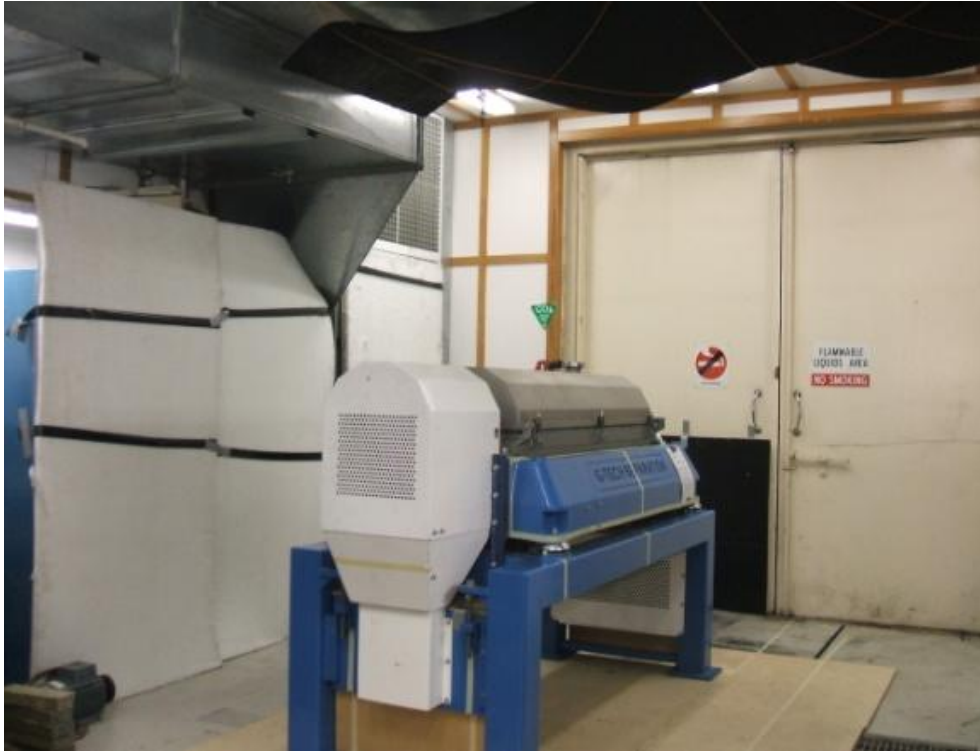
Figure 4 Sound absorption behind decanter

The testing was carried out using four speaker and microphone positions and twelve measurements were taken. Due to the laboratory having a large amount of steel ducting (see Figures 4 to 6), sound absorption material was added around the surfaces closest to the decanter. The material used was a black 22 mm thick polyurethane foam and a white 30 mm thick polyester board.

The first test was conducted with the standard amount of absorption placed within the room, as shown in Figures 4 and 5. The results of the measurements are shown in Figure 18. The results show that area 4 and 8 have a relatively high δ_{pI} for all frequencies. This is due to the low noise radiating from the decanter parts within these regions compared to the noise levels generated within the adjacent regions. Overall the results can be considered good quality for the 200 Hz one-third octave band and above. The lower frequency bands cannot be classified as good quality using the δ_{pI} measurements.

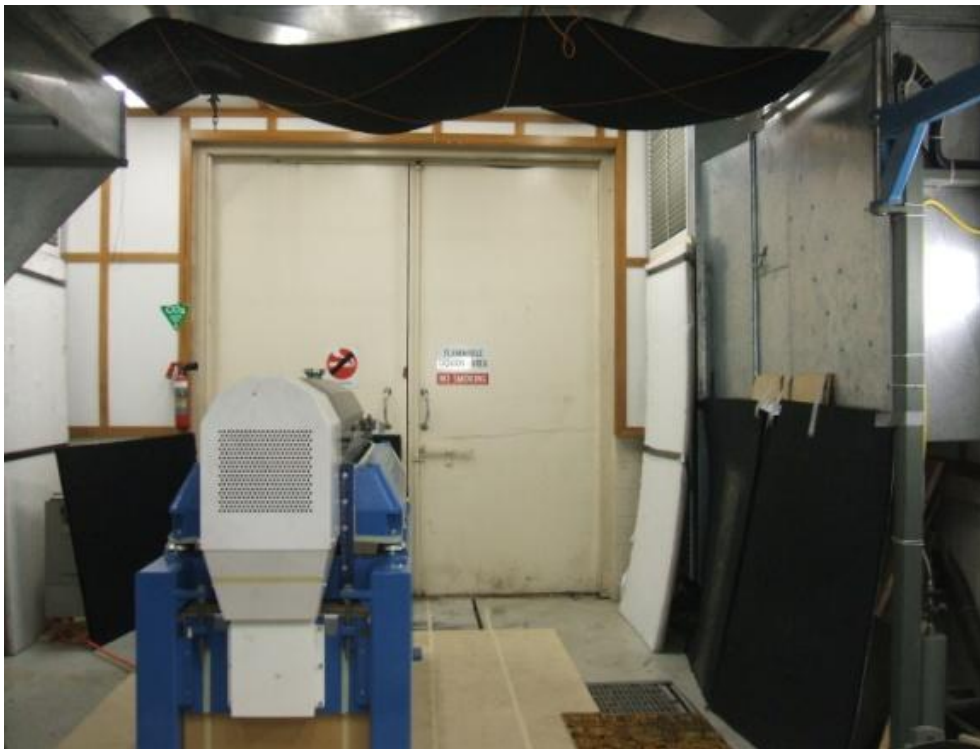
Figure 5 Sound absorption in front of decanter

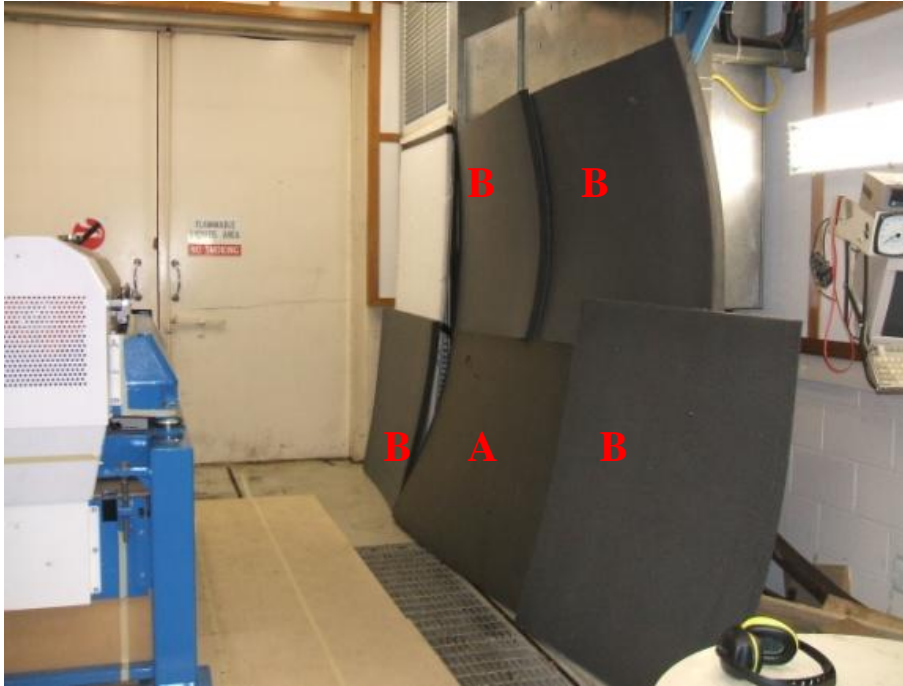
Figure 19 Additional Sound Absorption

The second test was conducted with sound absorption material added to the room as shown in Figure 18. The added absorption consisted of a 100 mm thick polyurethane foam sheet 1.2 x 2.4m (A) and 4 x 50 mm thick polyurethane foam sheets 1.2 x 1.4m (B). The results of the measurements are shown in Figure 20. The results show a slight increase in quality over all the frequencies but the measurements below the 200 Hz one-third octave band can still not to be classified as good ‘quality’.
